Evaluation Report No. E1980B Printed: July, 1981 Tested at: Lethbridge ISSN 0383-3445

# **Evaluation Report 235**

# Massey Ferguson Model 124 Baler

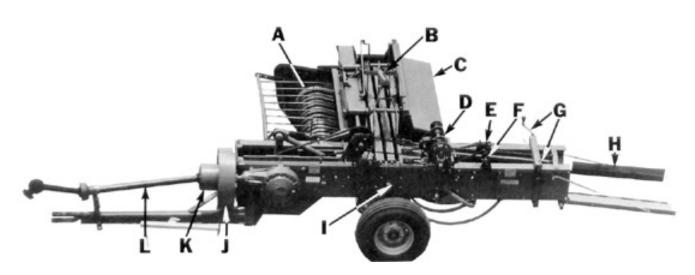
FIGURE 1. Massey Ferguson 124 Baler: (A) Pickup, (B) Packer Fork, (C) Twine Box, (D) Knotters, (E) Metering Wheel, (F) Metering Arm, (G) Bale Density Adjustment, (H) Quarter Turn Bale Chute, (I) Bale Chamber, (J) Flywheel, (K) Slip Clutch, (L) Power Shaft.

FIGURE 1 shows the location of major components while detailed specifications are given in APPENDIX I.

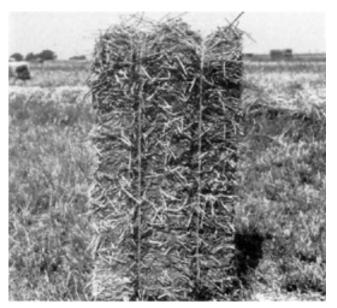
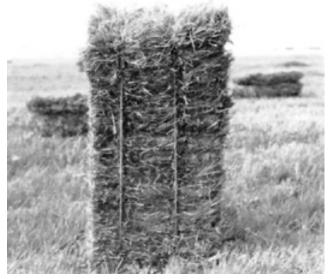
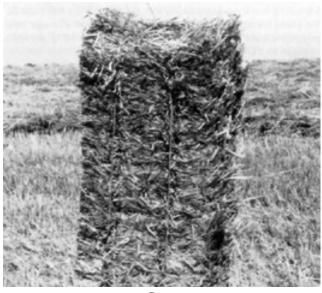
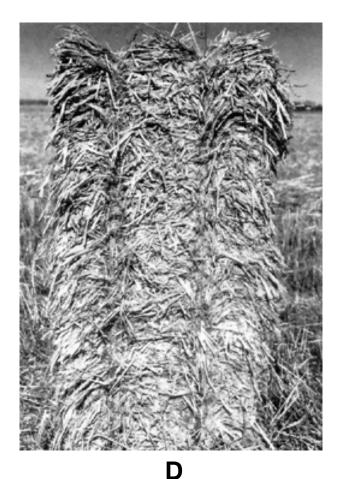
*Bale Quality:* The Massey Ferguson 124 was capable of producing firm, durable bales with square ends in all crops (FIGURE 2). Average hay bales weighed 22 to 35 kg (48 to 77 lb), while average straw bales weighed 20 to 25 kg (44 to 55 lb). Average bale density varied form 142 to 235 kg/m³ (8.5 to 14.1 lb/ft³) in hay and 127 to 145 kg/m³ (7.6 to 8.7 lb/ft³) in straw.

FIGURE 2. Typical Bales: (A) Alfalfa, (B) Bromegrass, (C) Greenfeed, (D) Straw.
